### CONCERN

A severely damaged pipe bridge needed to be quickly replaced without impacting plant production.

### DUNBAR'S SOLUTION

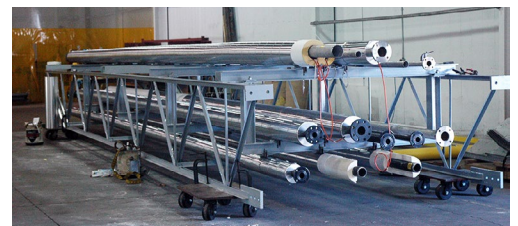
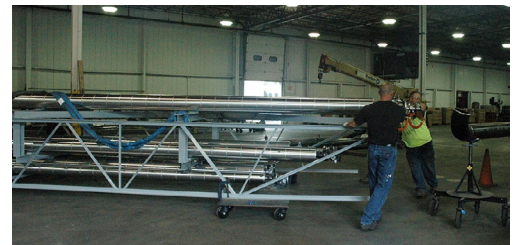
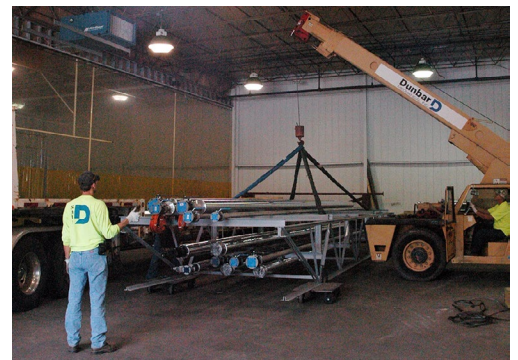
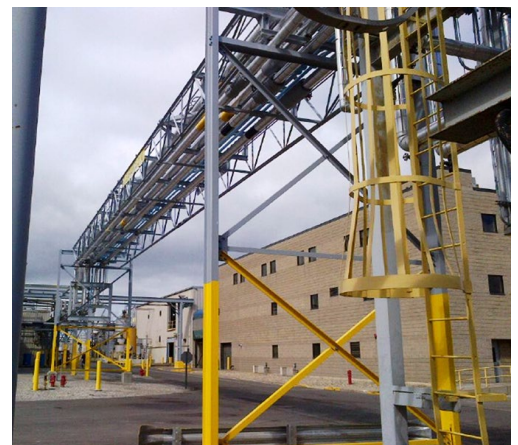
- placed 14 pipes that were 80' in length on a 75' long x 4' high x 8' wide pipe support truss.
- fabricated a splice plate in the middle of the truss so the unit could be separated into two pieces to be transported.
- bolted valves at both ends of each of the pipes.
- heat traced and insulated the pipes.
- divided the unit, rigged it and transported it to the facility.

While this was in production at Dunbar, our crews on site built columns to support the new pipe bridge adjacent to the damaged bridge. When the units arrived at the facility they were re-connected (this time permanently) through flanged and welded connections. The 80' unit was then lifted by crane and installed 25' above the ground, over the existing bridge. Dunbar Mechanical completed the project by demolishing and removing the damaged (and now unneeded) piping structure.
