### CONCERN

A severely damaged pipe bridge needed to be quickly replaced without impacting plant production.

### DUNBAR'S SOLUTION

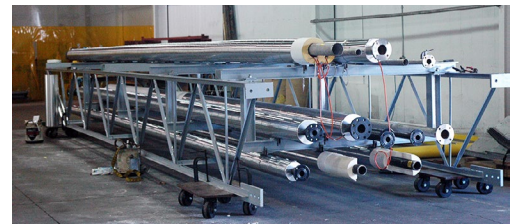
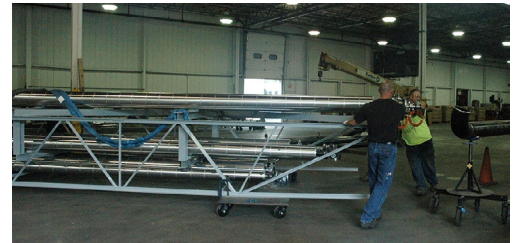
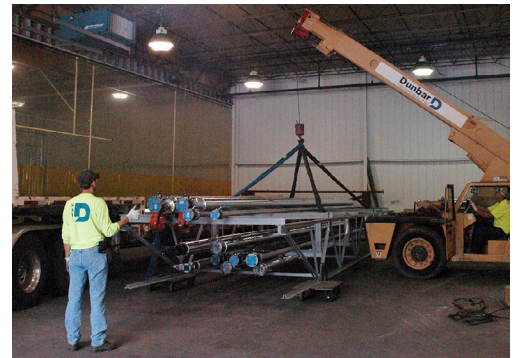
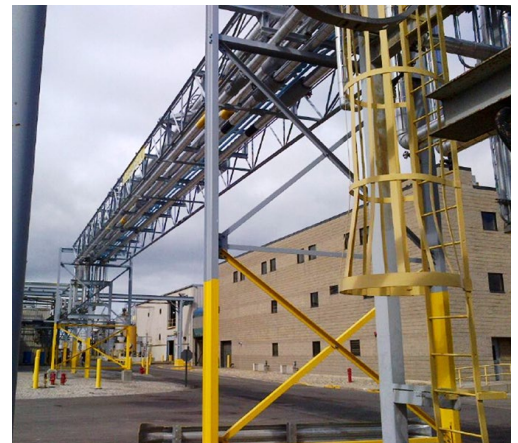
- placed 14 pipes that were 80' in length on a 75' long x 4' high x 8' wide pipe support truss.
- fabricated a splice plate in the middle of the truss so the unit could be separated into two pieces to be transported.
- bolted valves at both ends of each of the pipes.
- heat traced and insulated the pipes.
- divided the unit, rigged it and transported it to the facility.

While this was in production at Dunbar, our crews on site built columns to support the new pipe bridge adjacent to the existing unit. When the units arrived at the facility they were re-connected (this time permanently) through flanged and welded connections. The 80' unit was then lifted by crane and installed 25' above the ground, over the existing bridge. Dunbar Mechanical completed the project by demolishing and removing the damaged (and now unneeded) piping structure.
